NEW PALTZ CLIMATE SMART COMMUNITIES RIPARIAN BUFFER ASSESSMENT

Gillian Mathews, Cornell Cooperative Extension of Ulster County (CCEUC)

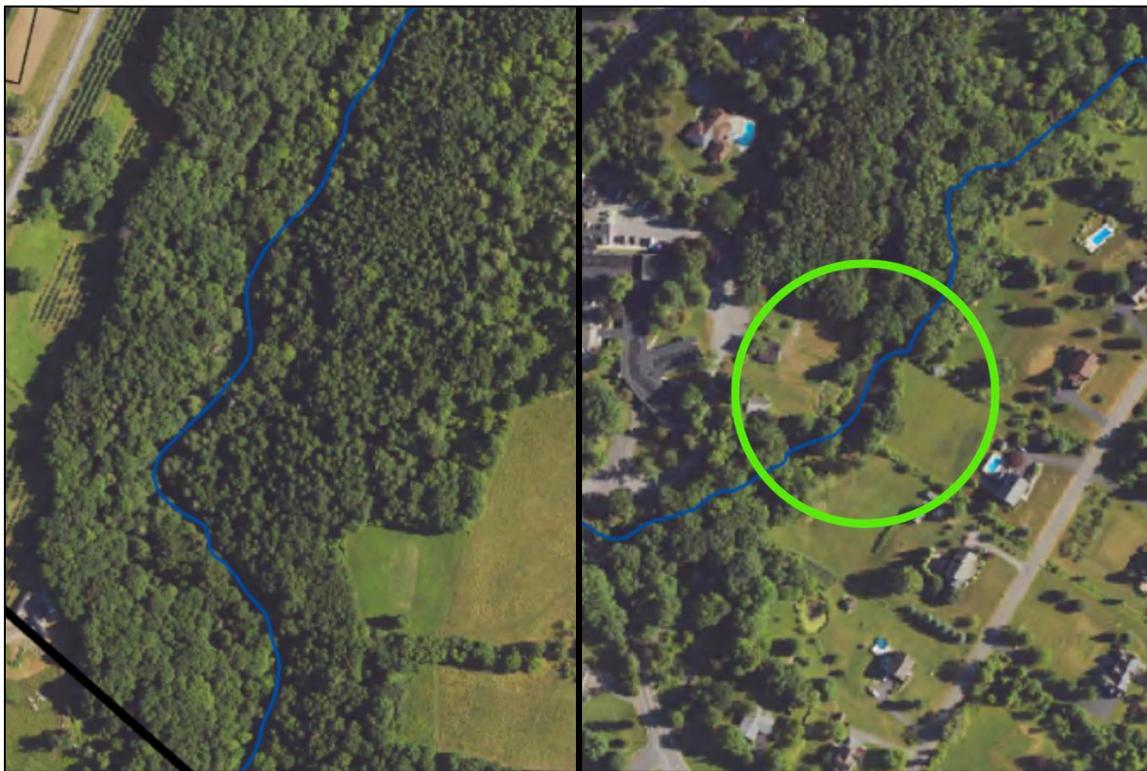
Beyond vegetation, we also observed hydrological features, including information related to stream meandering and potential sites susceptible to erosion. We also used the ROA tool to look at various factors such as water quality, habitat condition, and riparian vegetation health to better understand the overall health and functionality of each catchment.

Figure 15: Example of Aerial Imagery Analysis

Next, we reviewed aerial imagery to examine the selected catchments to identify riparian zones and their characteristics. We assessed the width and condition of the vegetation in these riparian areas, to aid in determining suitable locations for restoration or protection efforts.

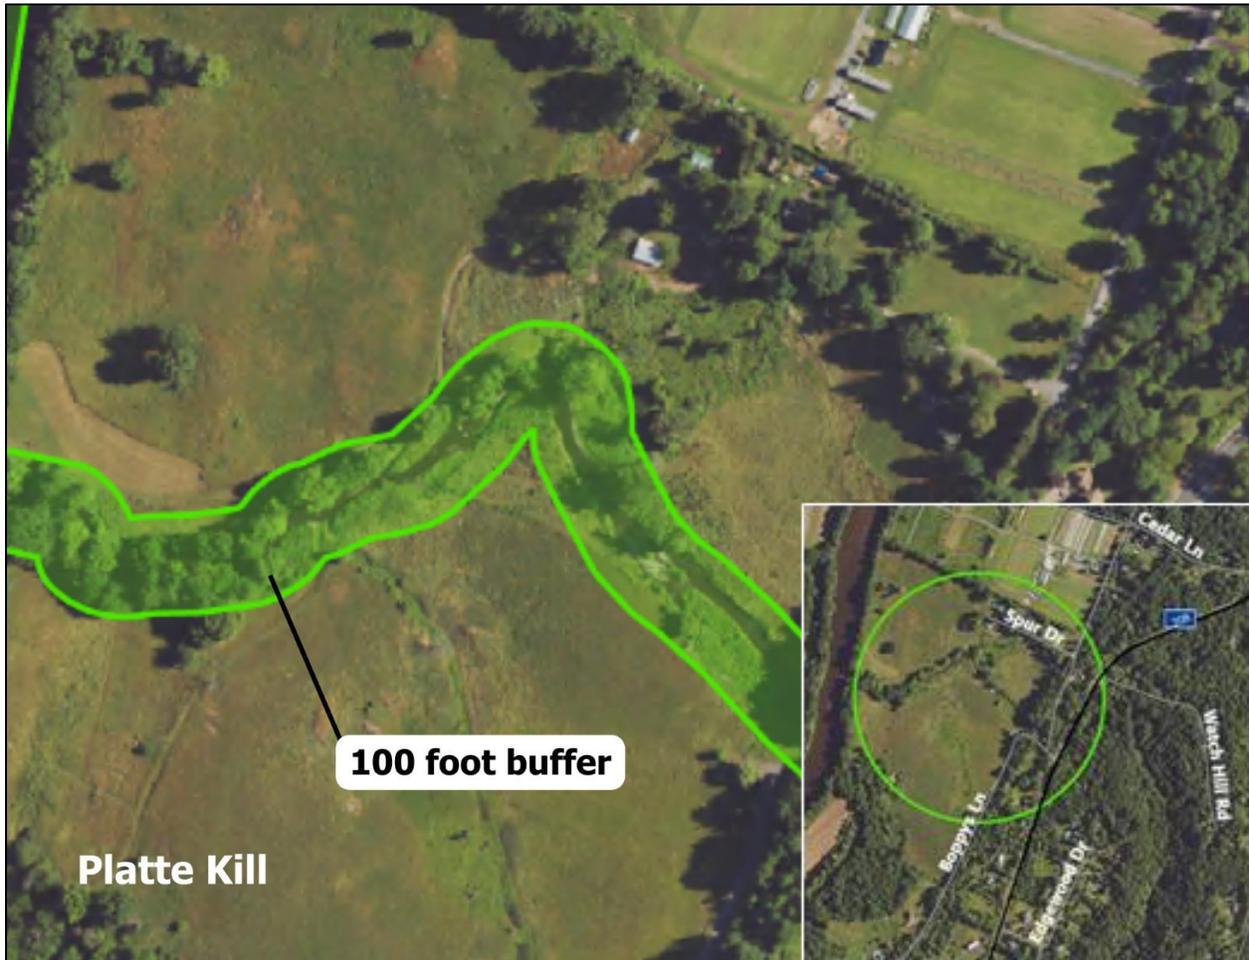
Restoration Focus Area B:

Focus area B is located within the Kleine Kill-Walkill River Subwatershed. More specifically, it is a part of the Platte Kill Brook, located in the southeastern quadrant of New Paltz.

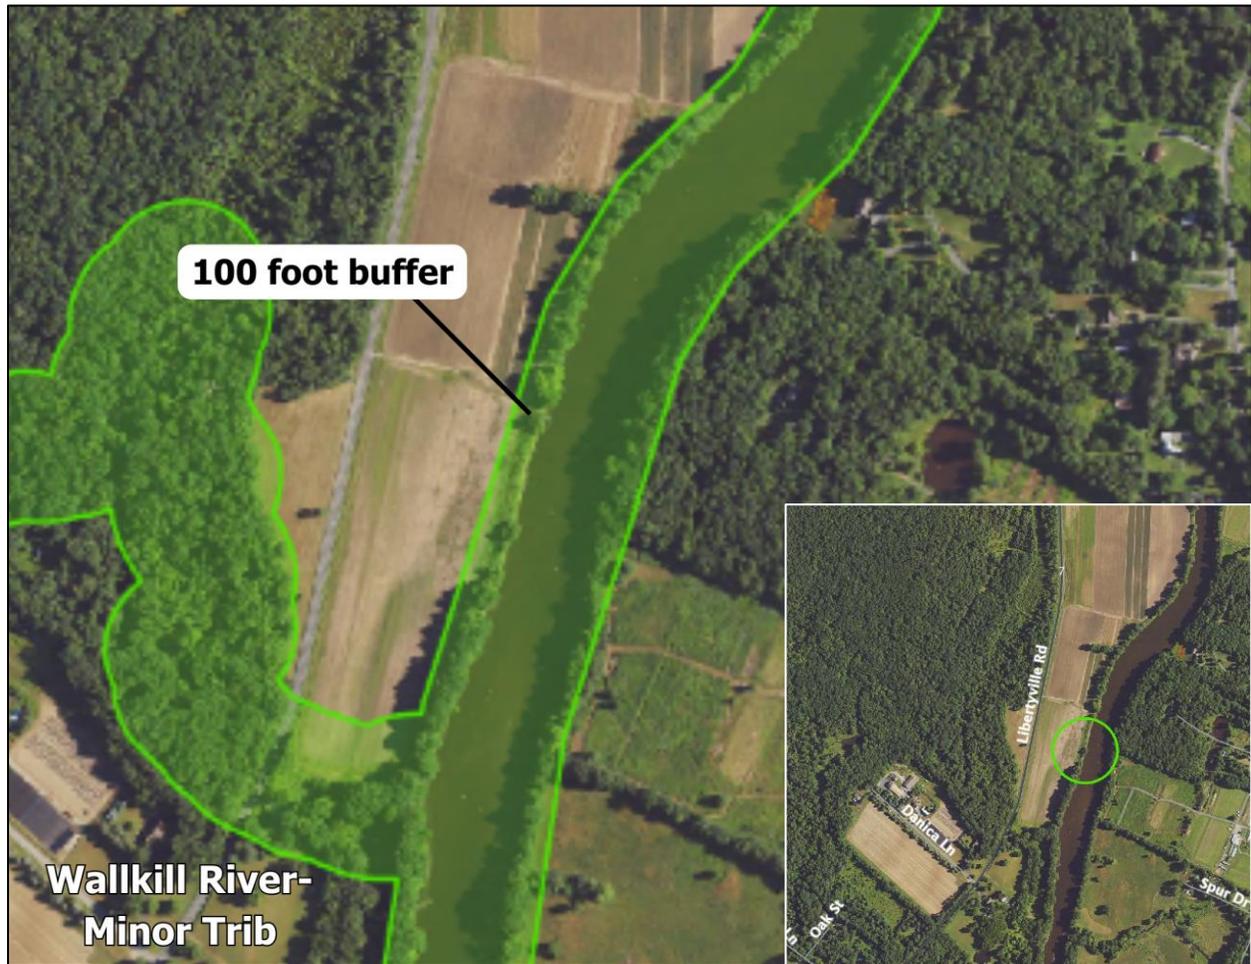
Restoration Focus Area F:

Focus area F is located within the Kleine Kill-Walkkill River Subwatershed. More specifically, it is located along the Walkkill River, located in the southwestern quadrant of New Paltz.

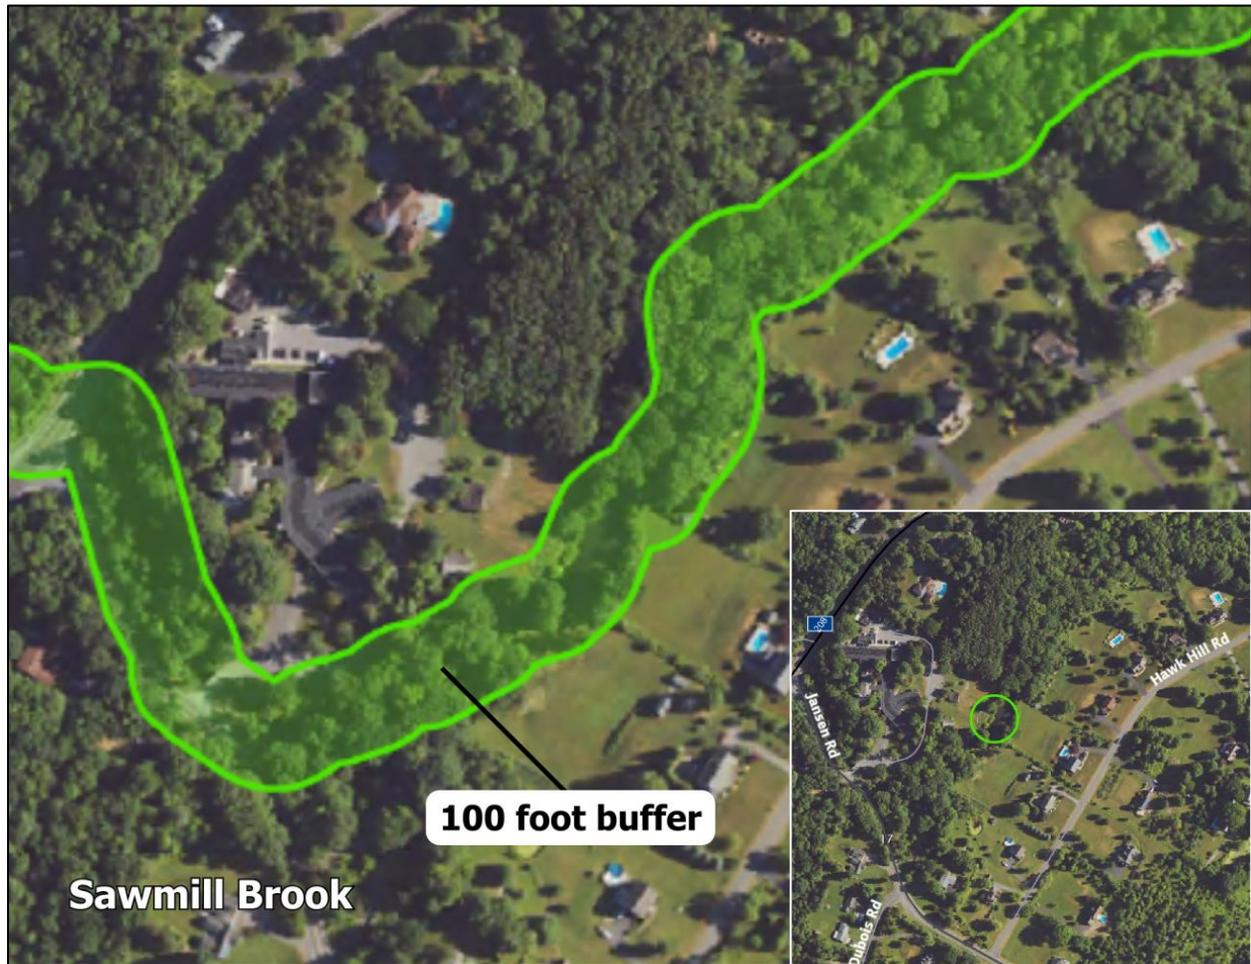
Restoration Focus Area G:

Focus area G is located within the Kleine Kill-Walkkill River Subwatershed. More specifically, it is located along the Sawmill Brook located in the southwestern quadrant of New Paltz.

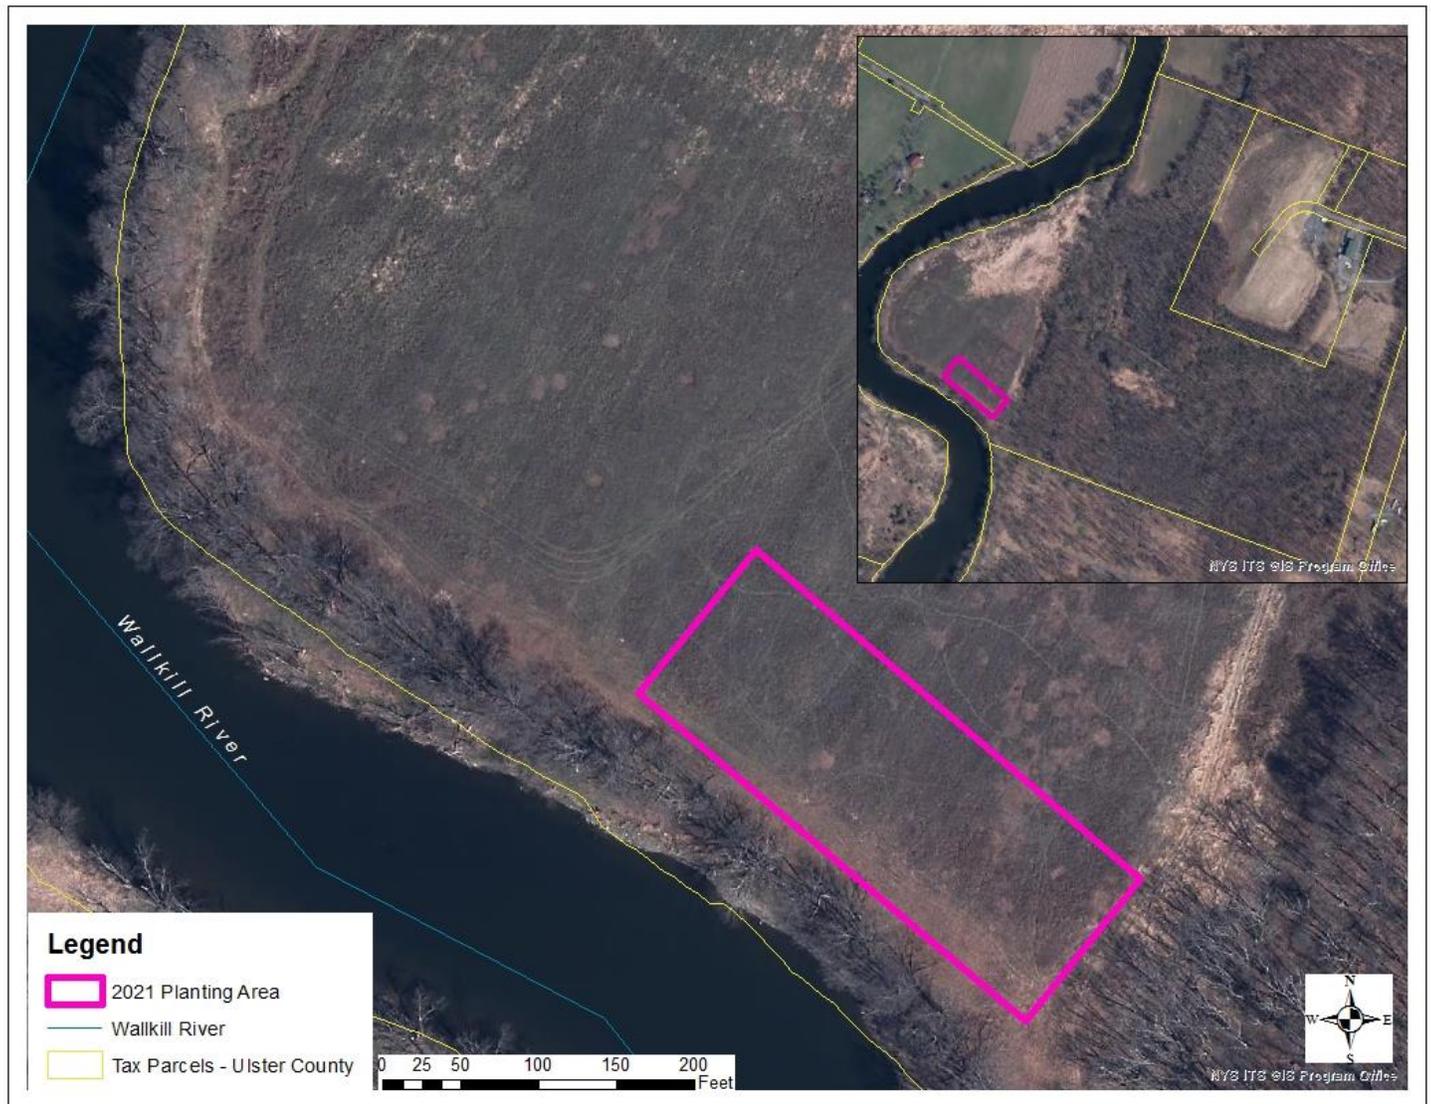
Spring 2021 Planting Plan Gardiner Riverbend Park

Approximate Planting Location
